# **Expedient Shelter Construction and Occupancy Experiments**

Cresson H. Kearny

**OAK RIDGE NATIONAL LABORATORY**

MARCH 1976

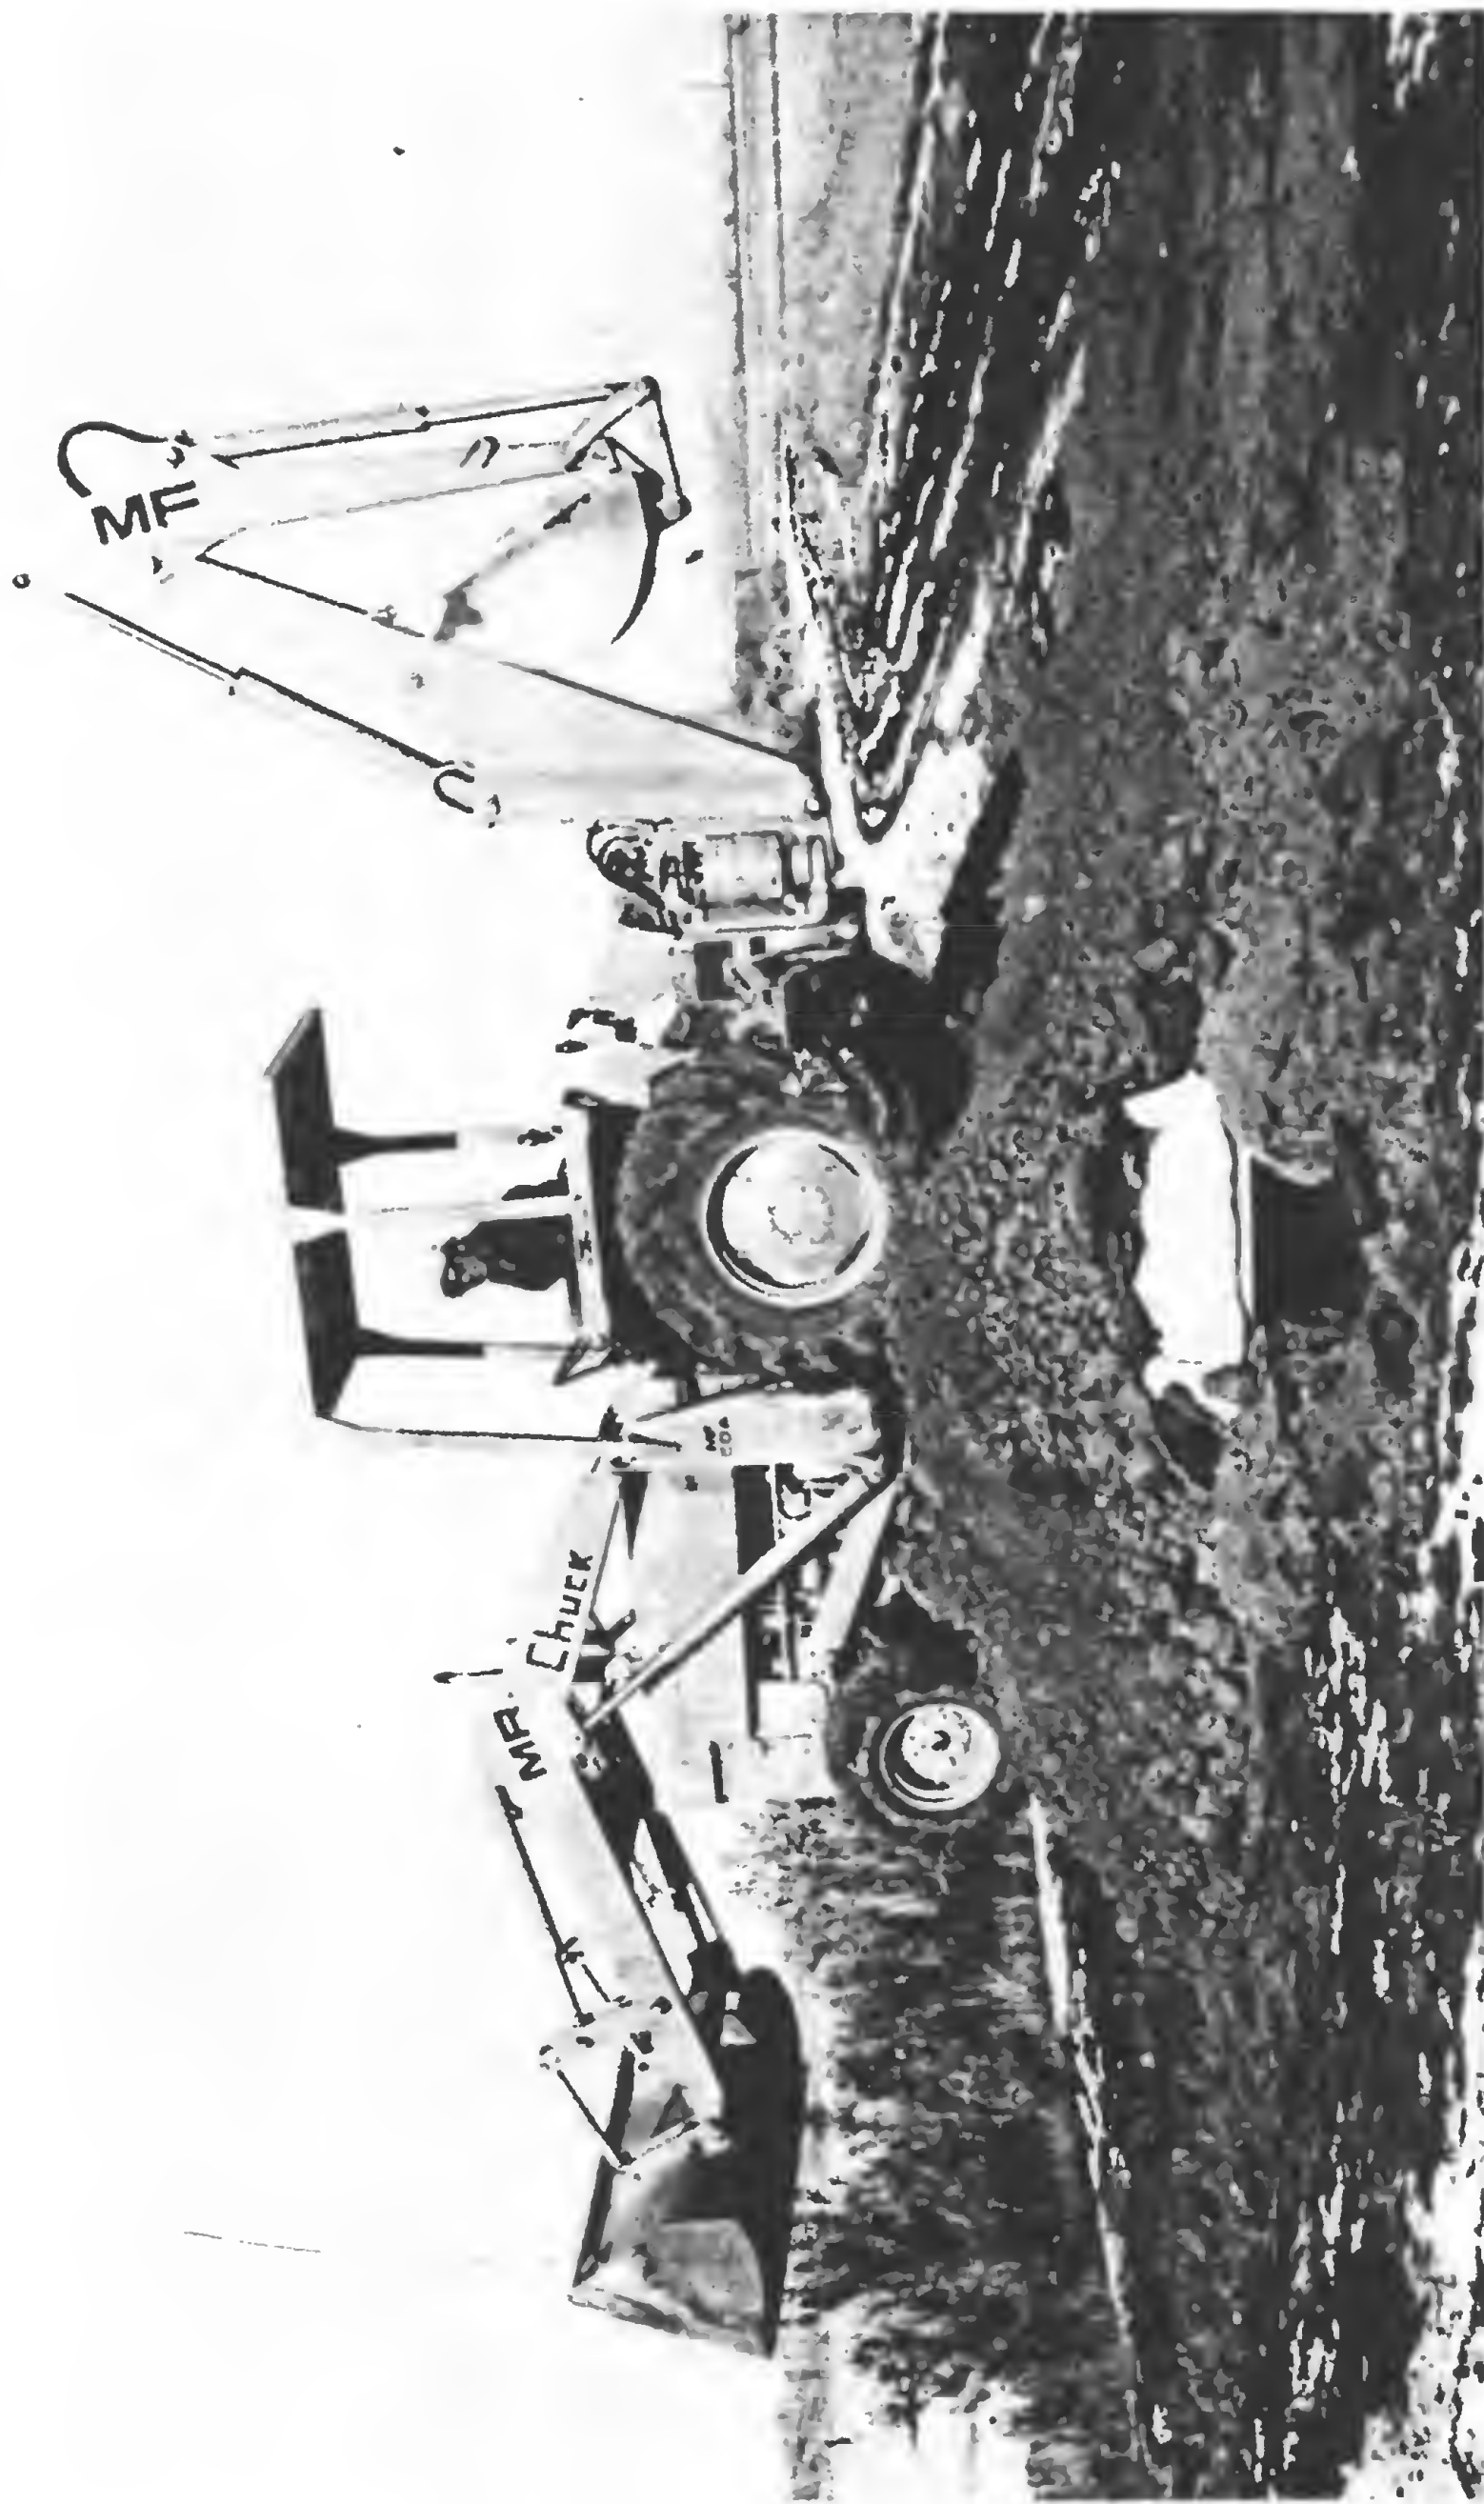
Fig. 3.3. An 8-ton backhoe on top of what was originally the 6½-ft-deep pile of earth over the shelter. Before this picture was taken, this machine had been driven back and forth several times over the mounded earth. The roofing doors remained undamaged, and were not observed to be bowed downward any more than when only the 6½-ft mound of earth was over them.

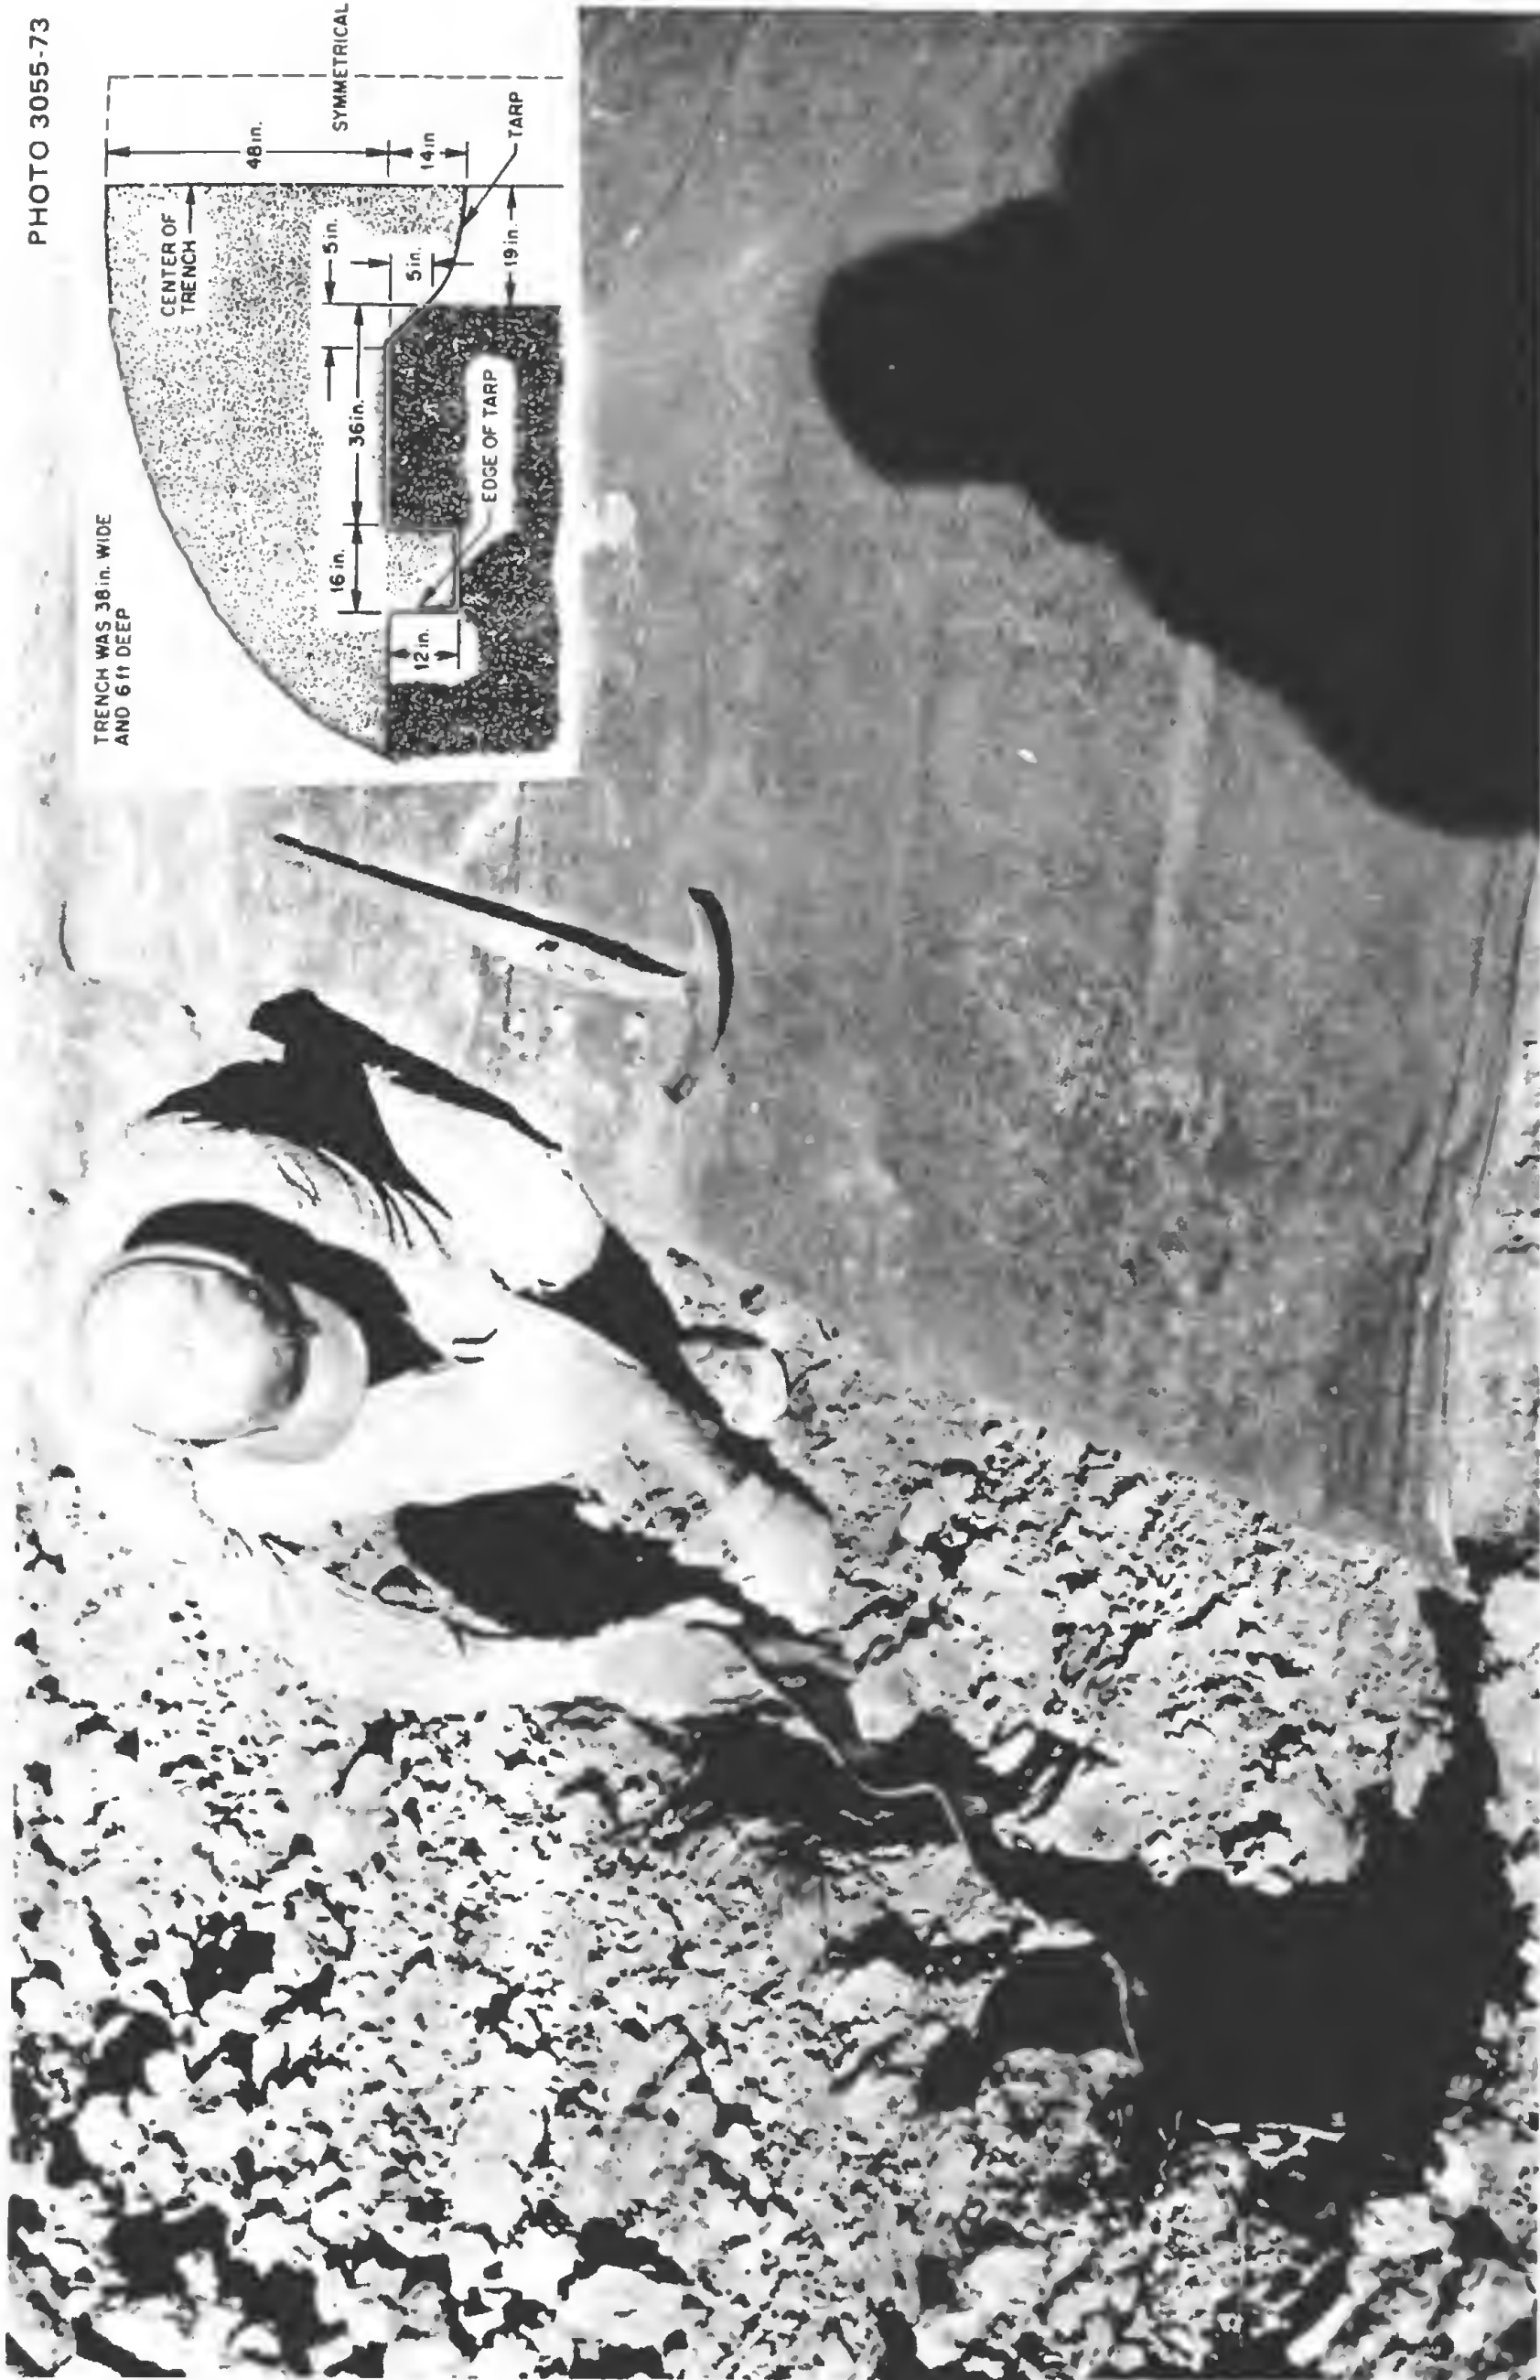
Fig. 3.11. Building the best of two successful Tarp-Roofed Trench Shelters constructed on Dec. 1, 1973, on the Kearny farm near Montrose, Colorado. C. H. Kearny designed this shelter after the November tests of the Door-Covered Trench Shelter had convinced him that, if the principles of earth arching and friction are used properly, then blast shelters can be built in many areas by roofing a trench with only a tarp or a strong rug, and then intelligently covering the tarp or rug with earth.

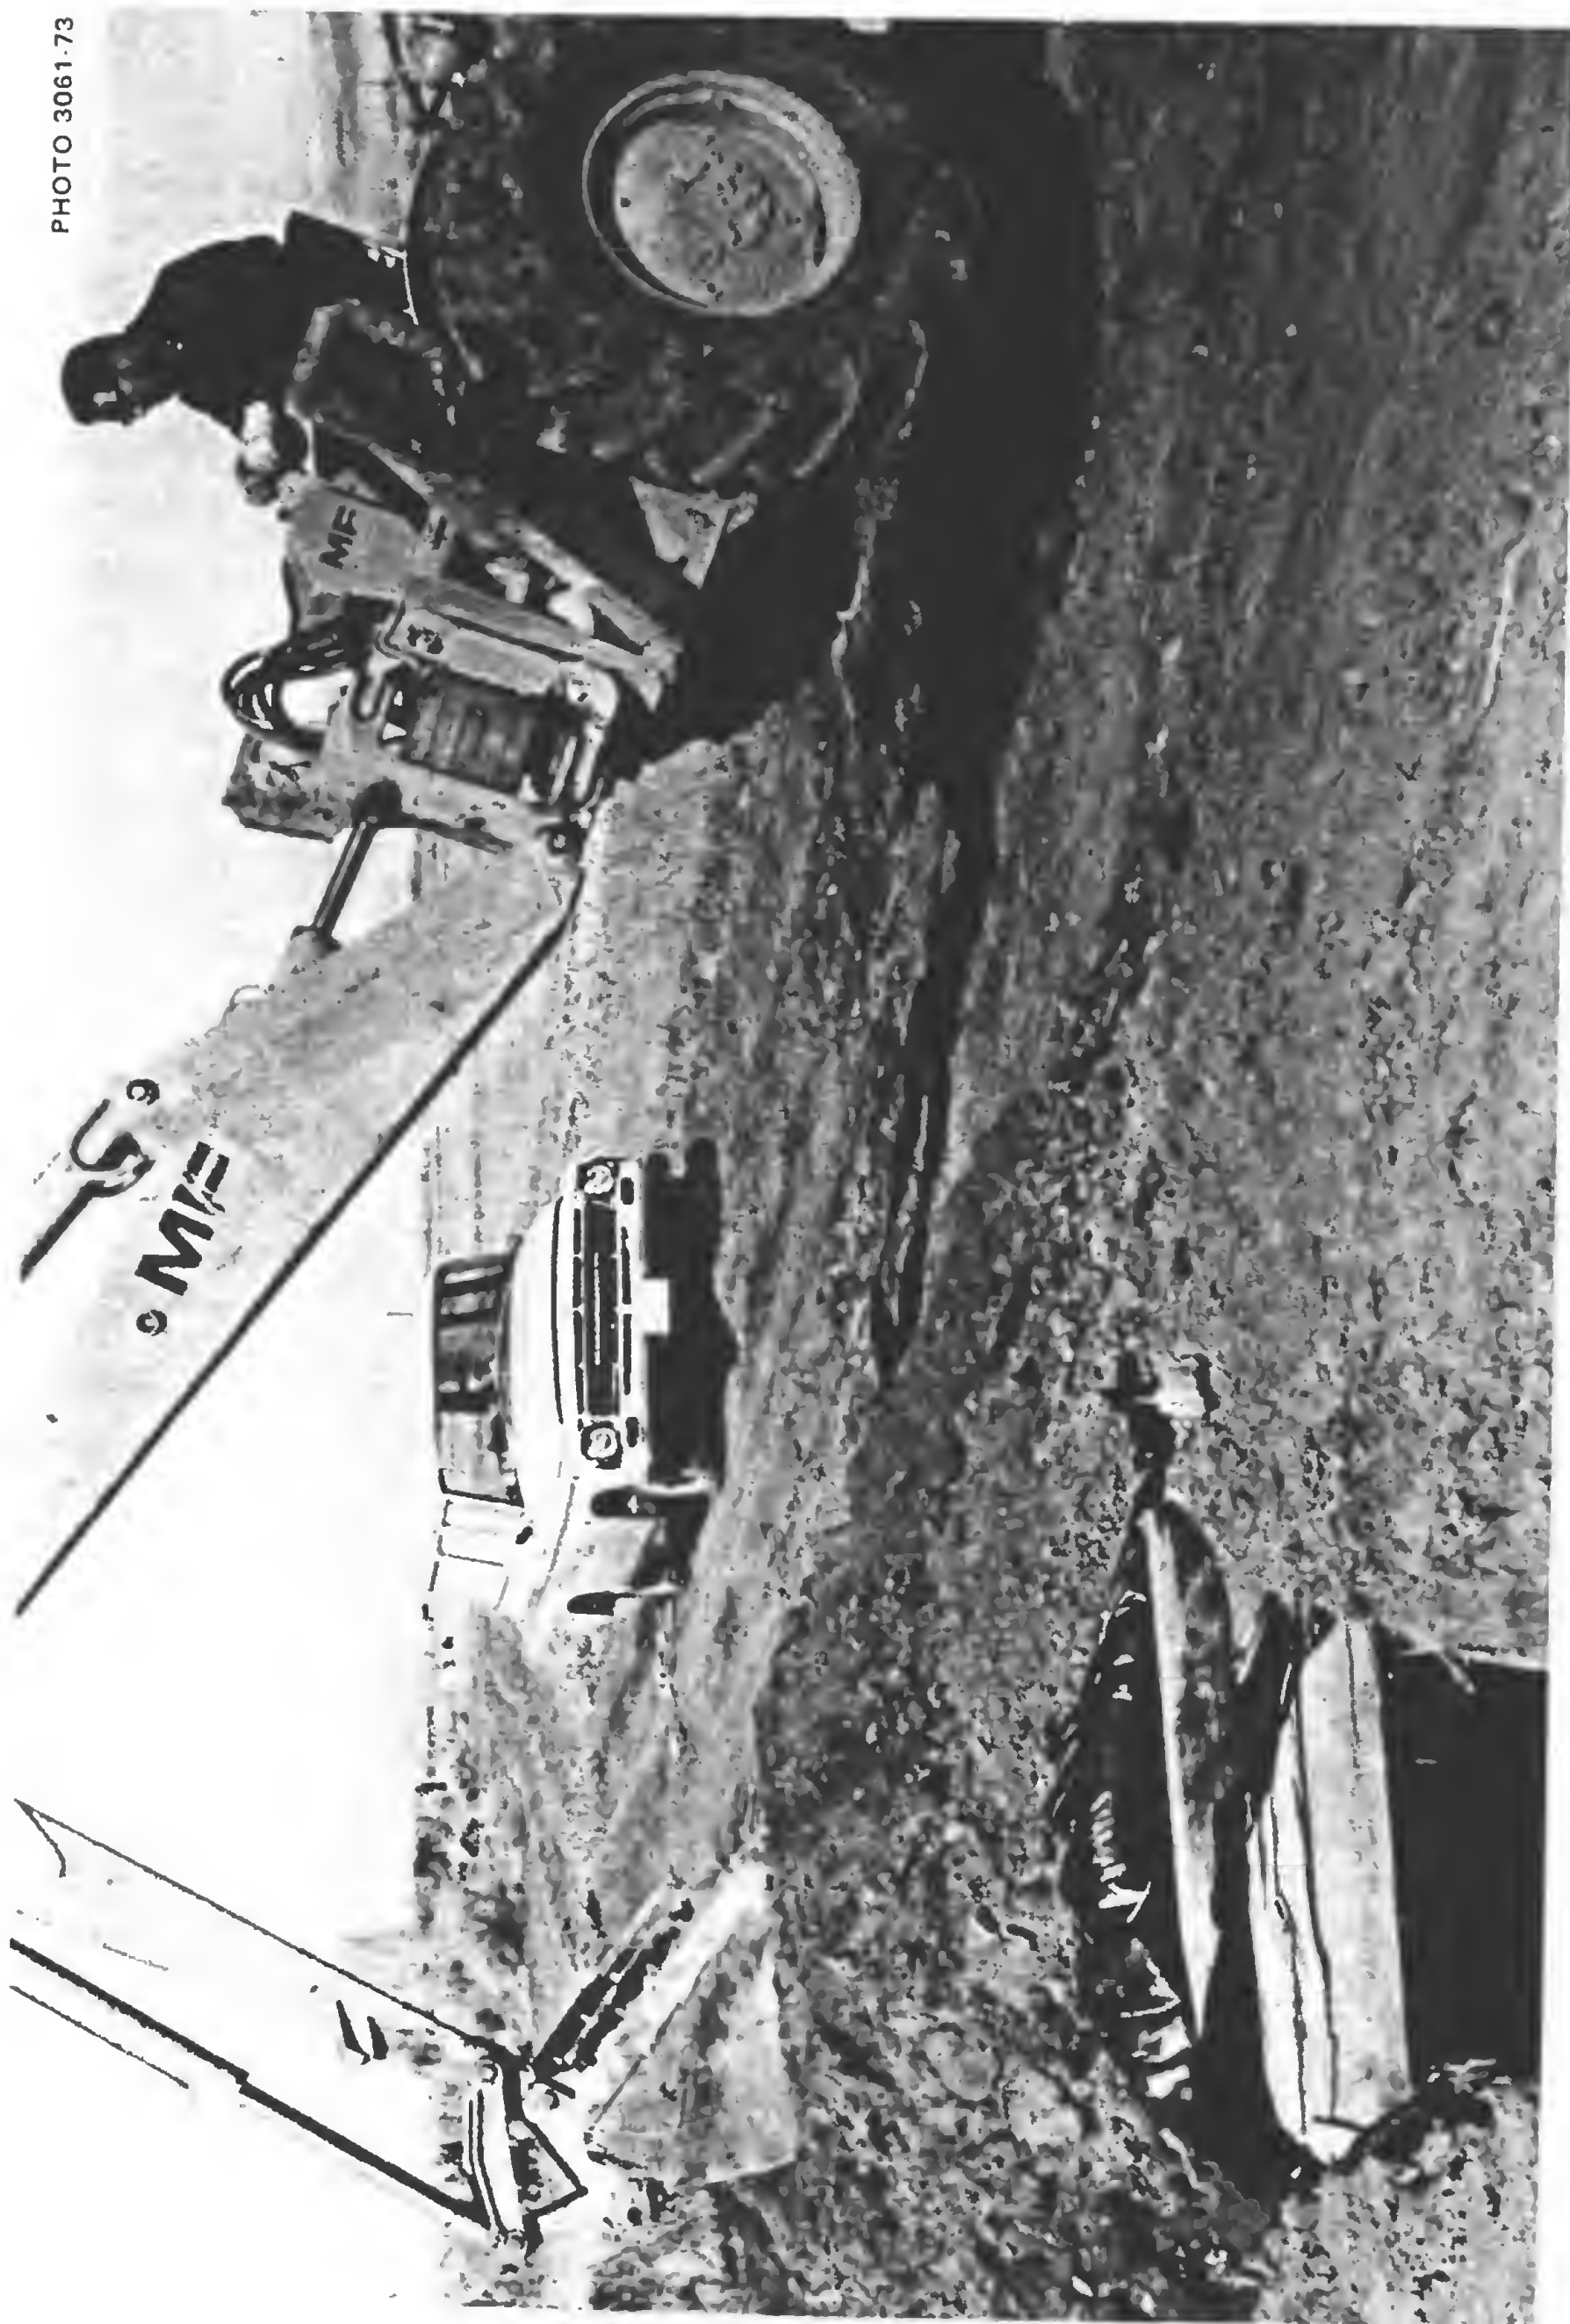
Fig. 3.13. Stressing the Tarp-Roofed Trench Shelter, a 6-ton backhoe, supported only by its buckets, pressed down repeatedly with its front bucket on a 62-in.-deep mound of loose earth. The mounding of loose earth caused the tarp to bow downward (sag) into a catenary curve. The compaction caused the tarp to stretch, resulting in an increase of the maximum sag from 8 to 14 in.

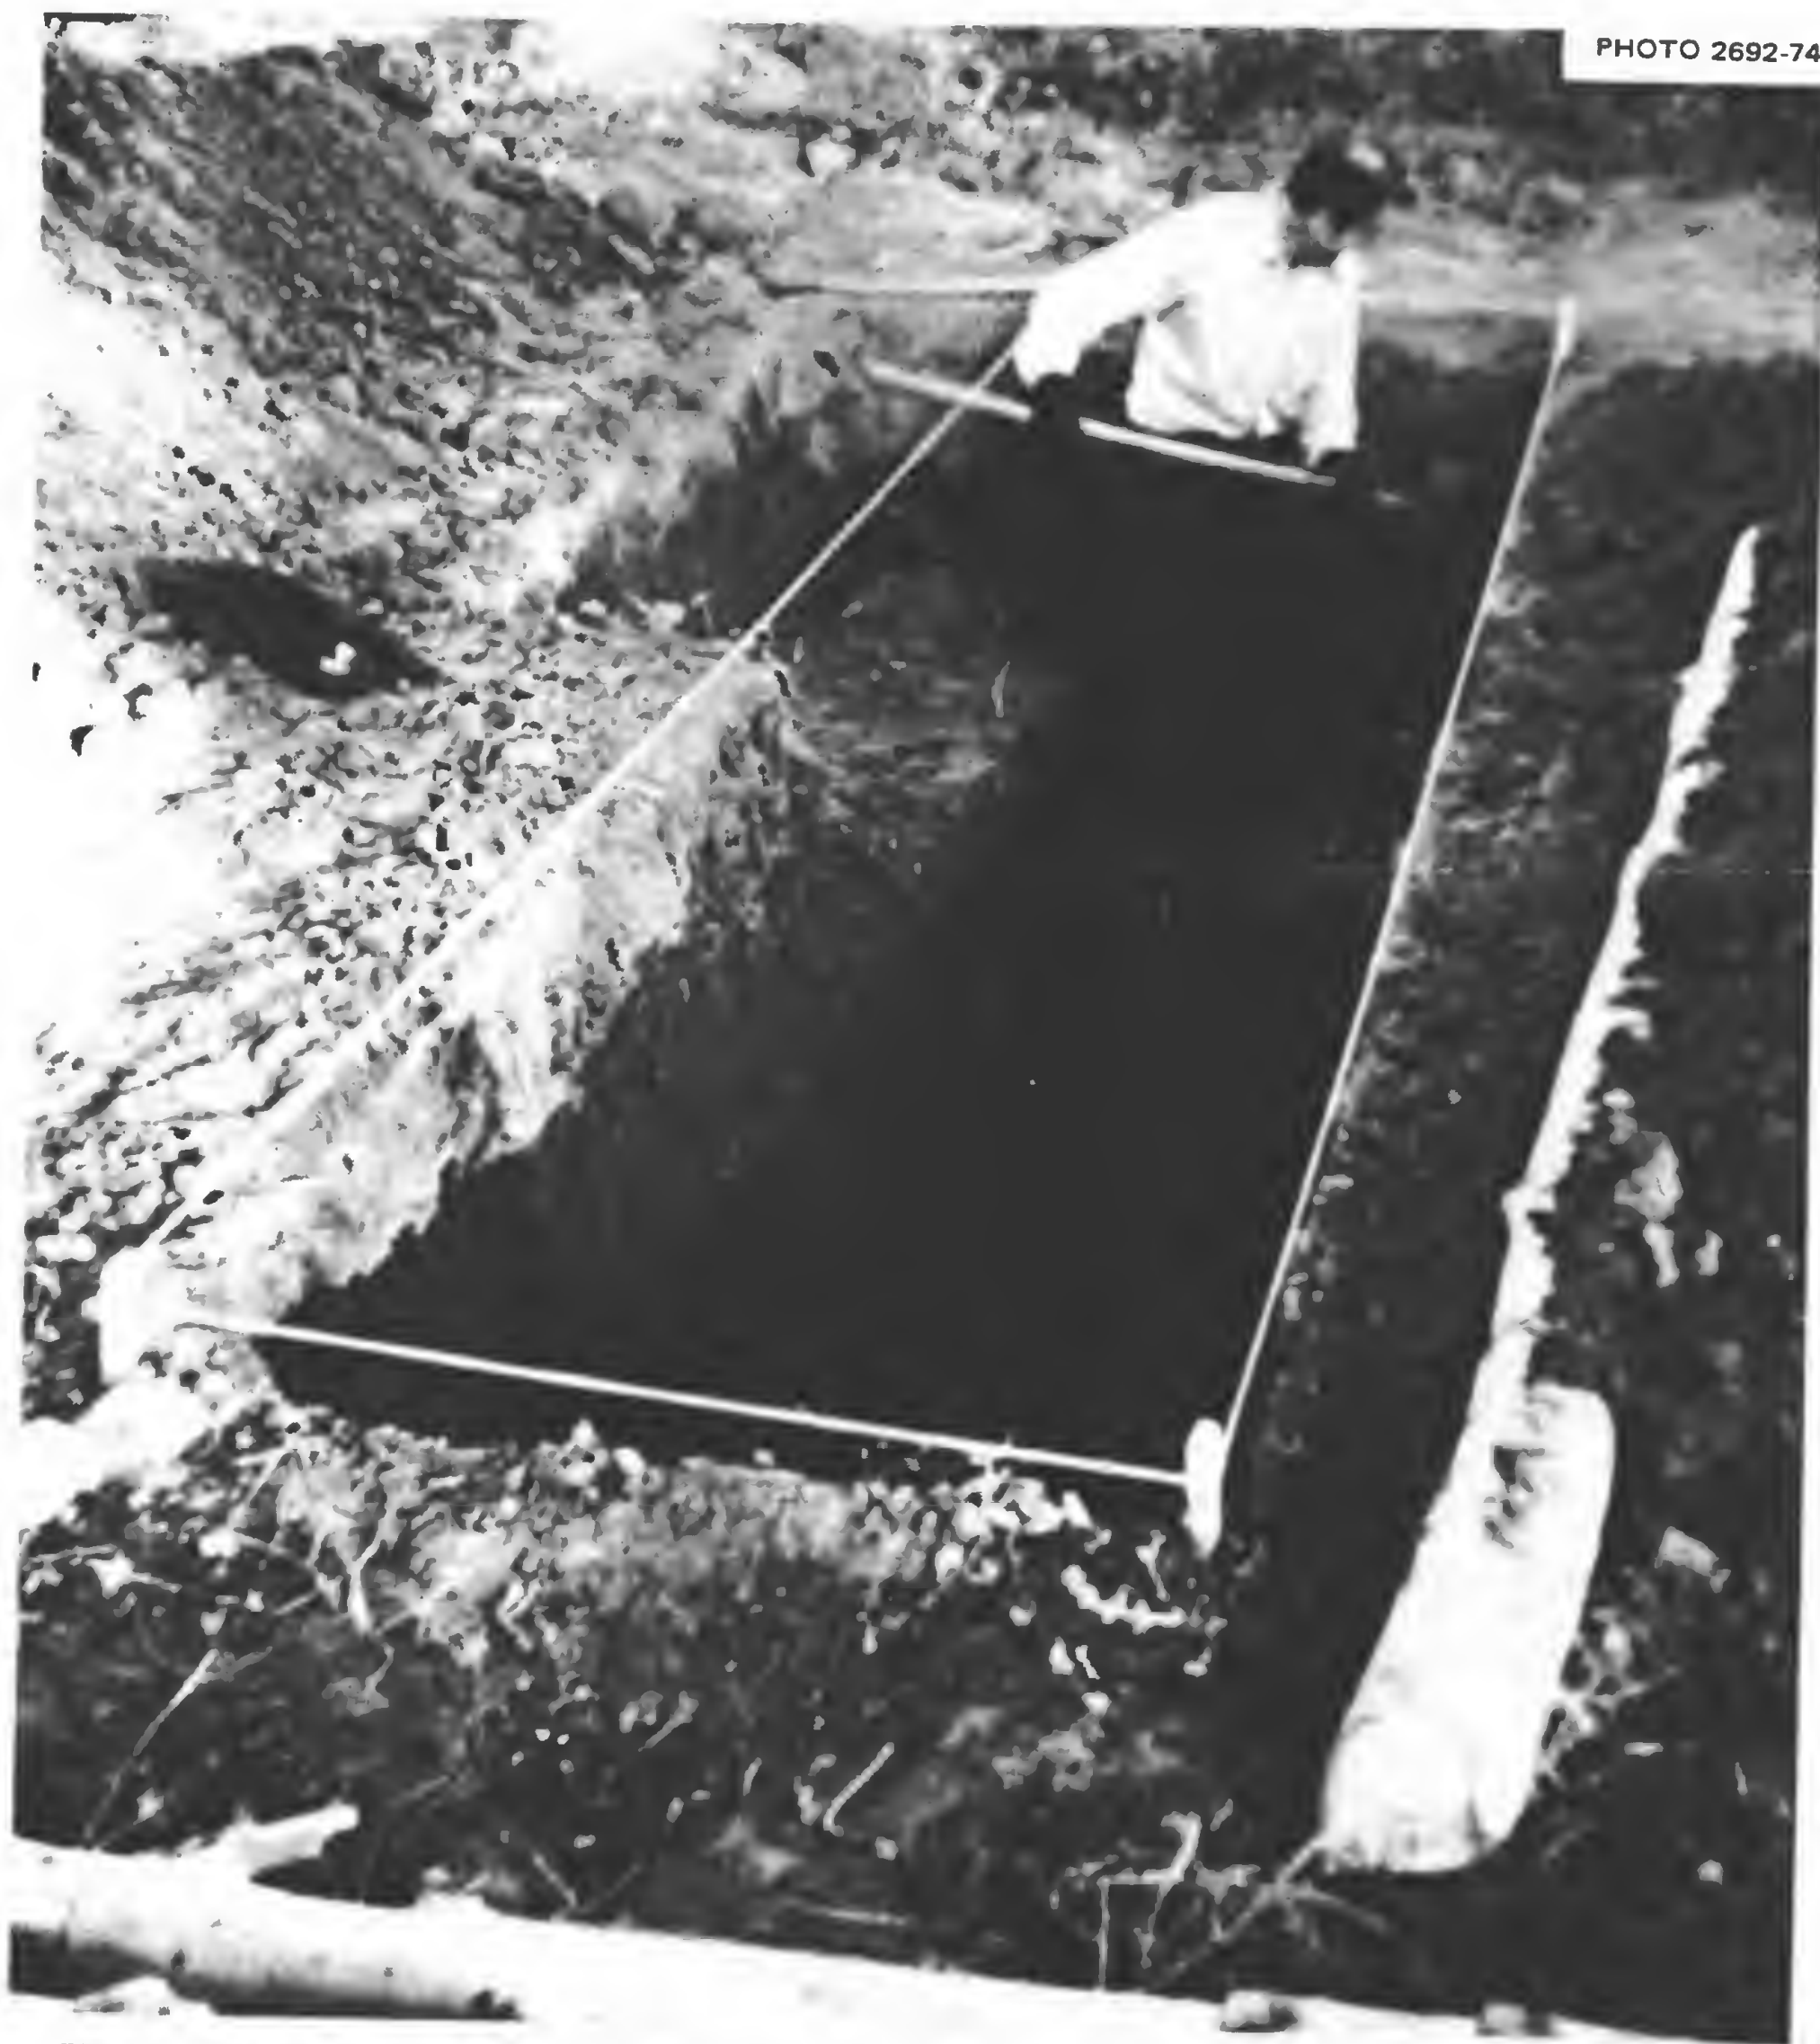
Fig. 4.4. Expanding the shelter room to its full specified width of  $3\frac{1}{2}$  feet, and to its  $4\frac{1}{2}$ -ft depth. This intelligent man made unnecessary work for himself by not following the instructions to cut a  $3\frac{1}{2}$ -ft stick, and then use it repeatedly to be sure the trench was being dug full width.

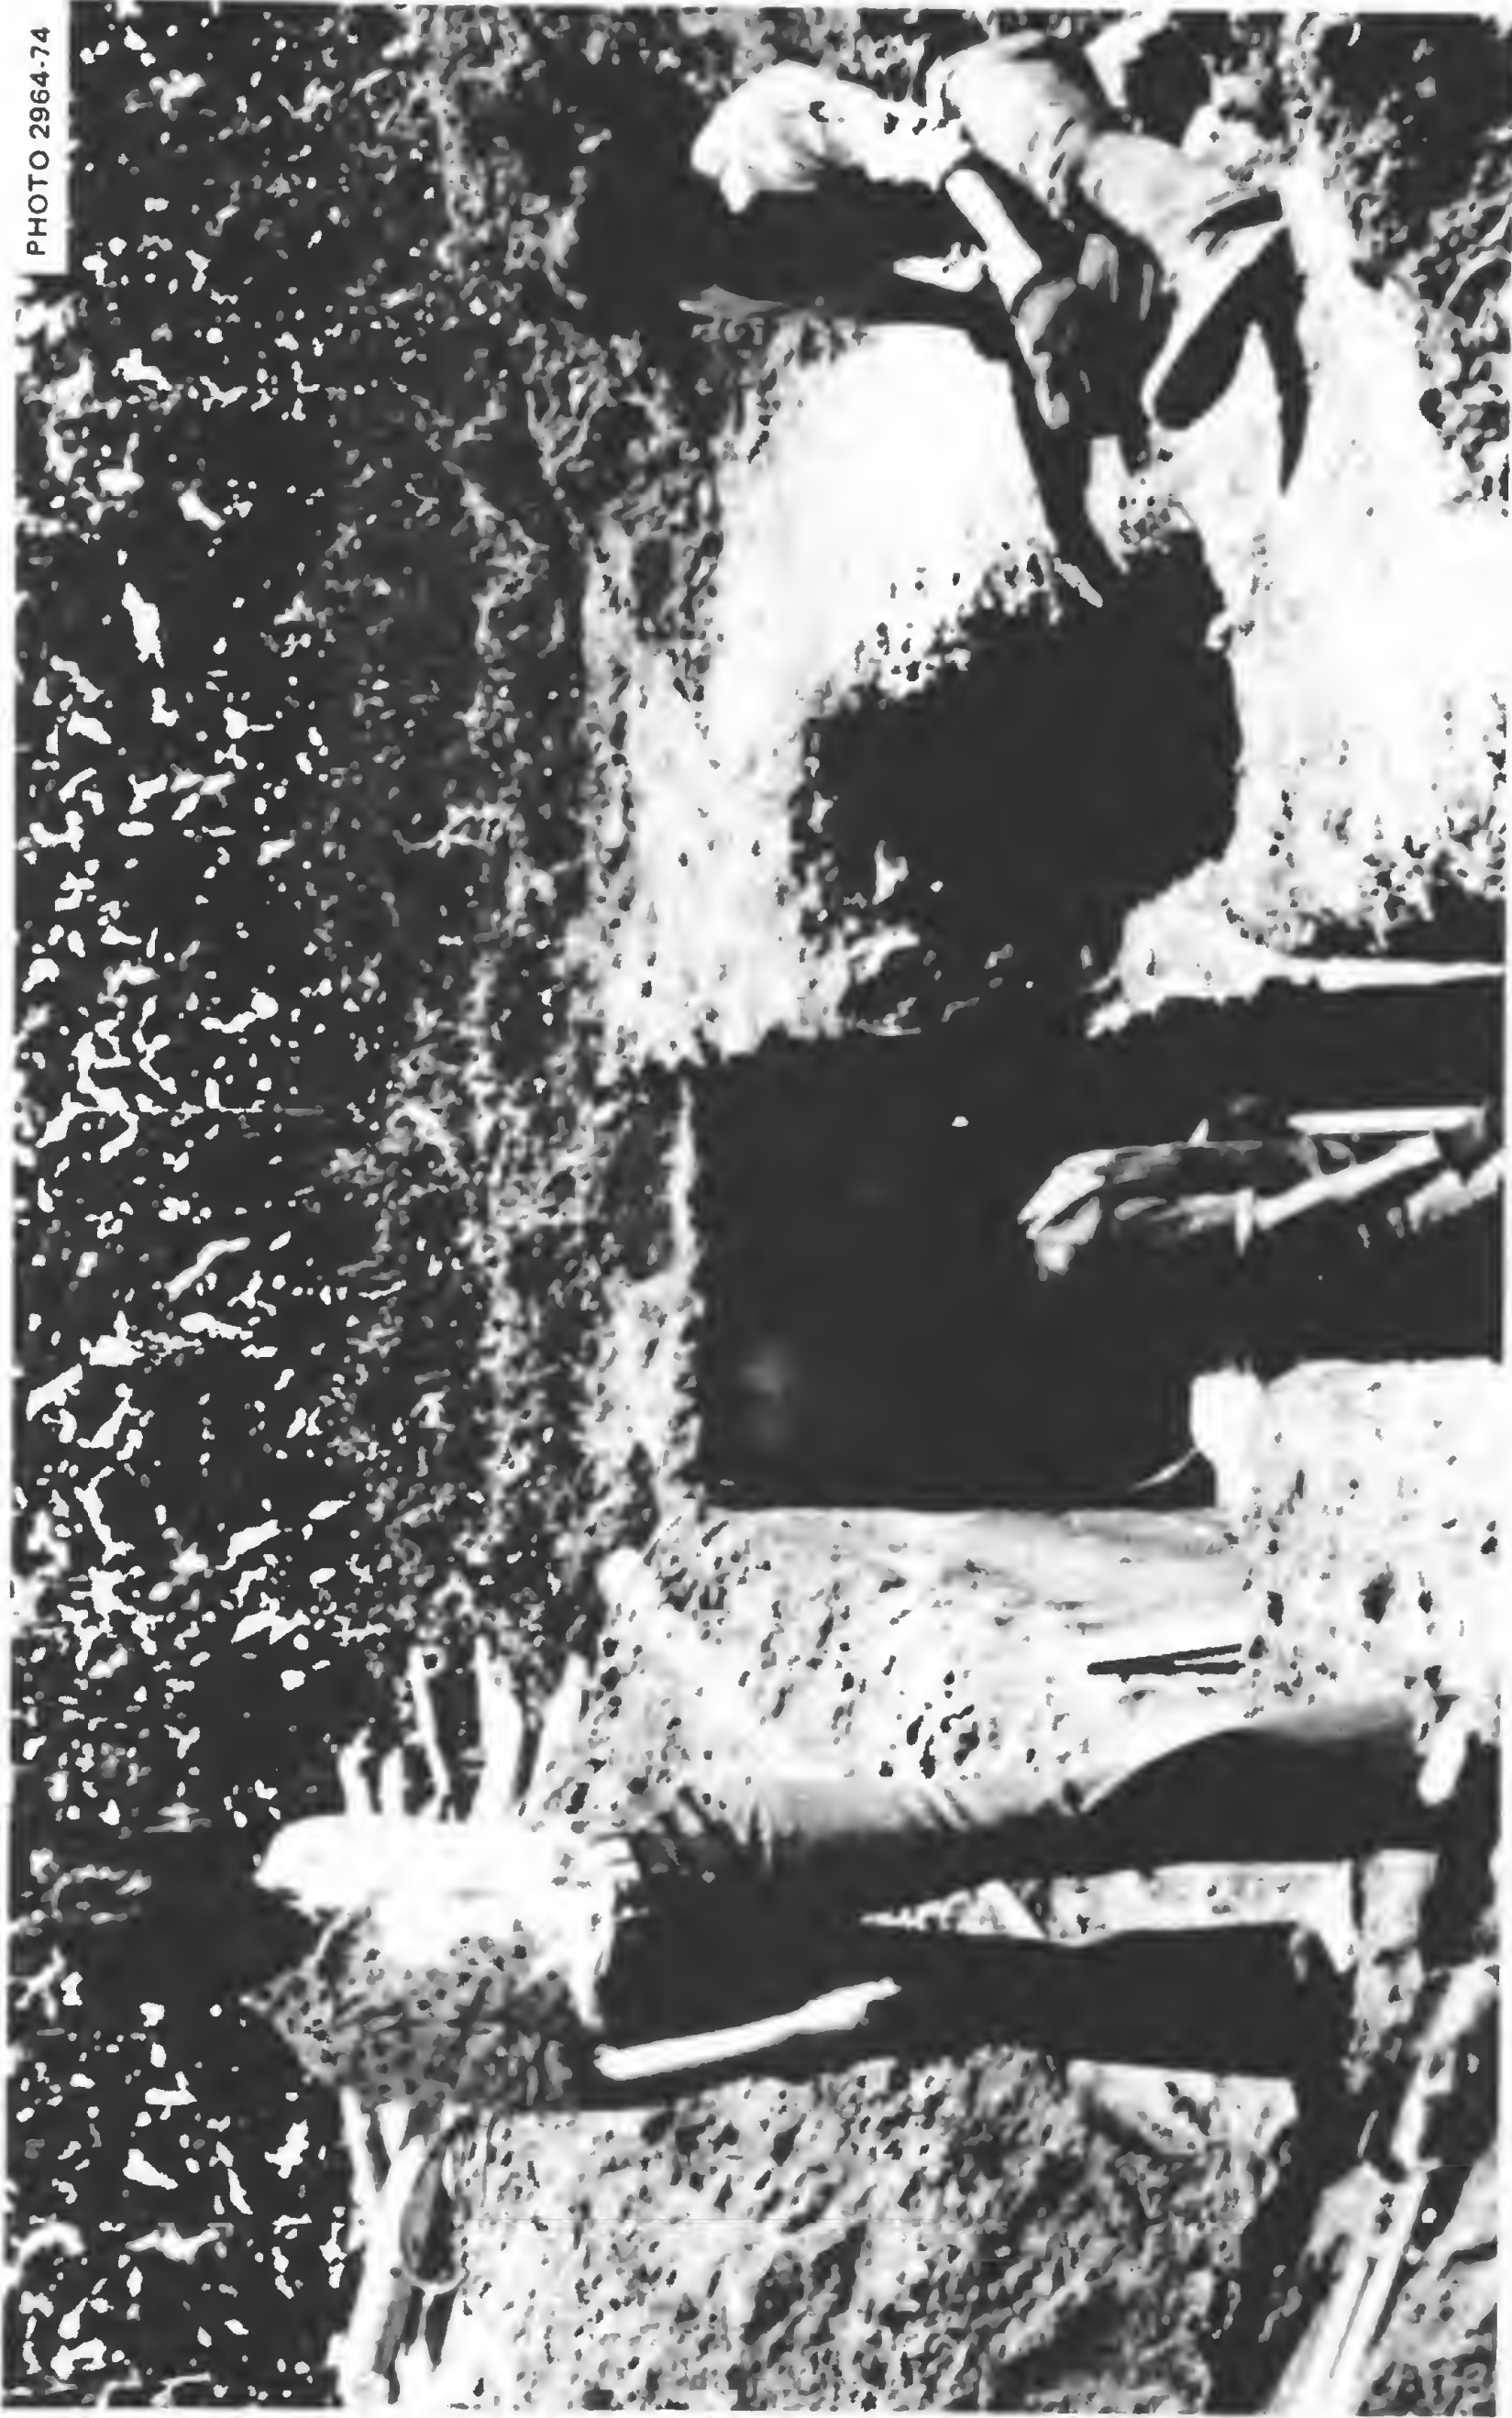
Fig. 4.5. The small ledgelike excavation on the side of the main trench was dug by Kearny to provide himself with a place to sleep and to observe the shelter-occupancy test. This sleeping ledge was  $2 \times 8$  ft, providing a height to the log roof of only 2 ft. After Kearny got a sore neck from turning around periodically on this sleeping ledge, with only a 24-in. ceiling, during the 77 hours of shelter occupancy, he concluded that such sleeping ledges should be dug to provide a 30-in. ceiling.

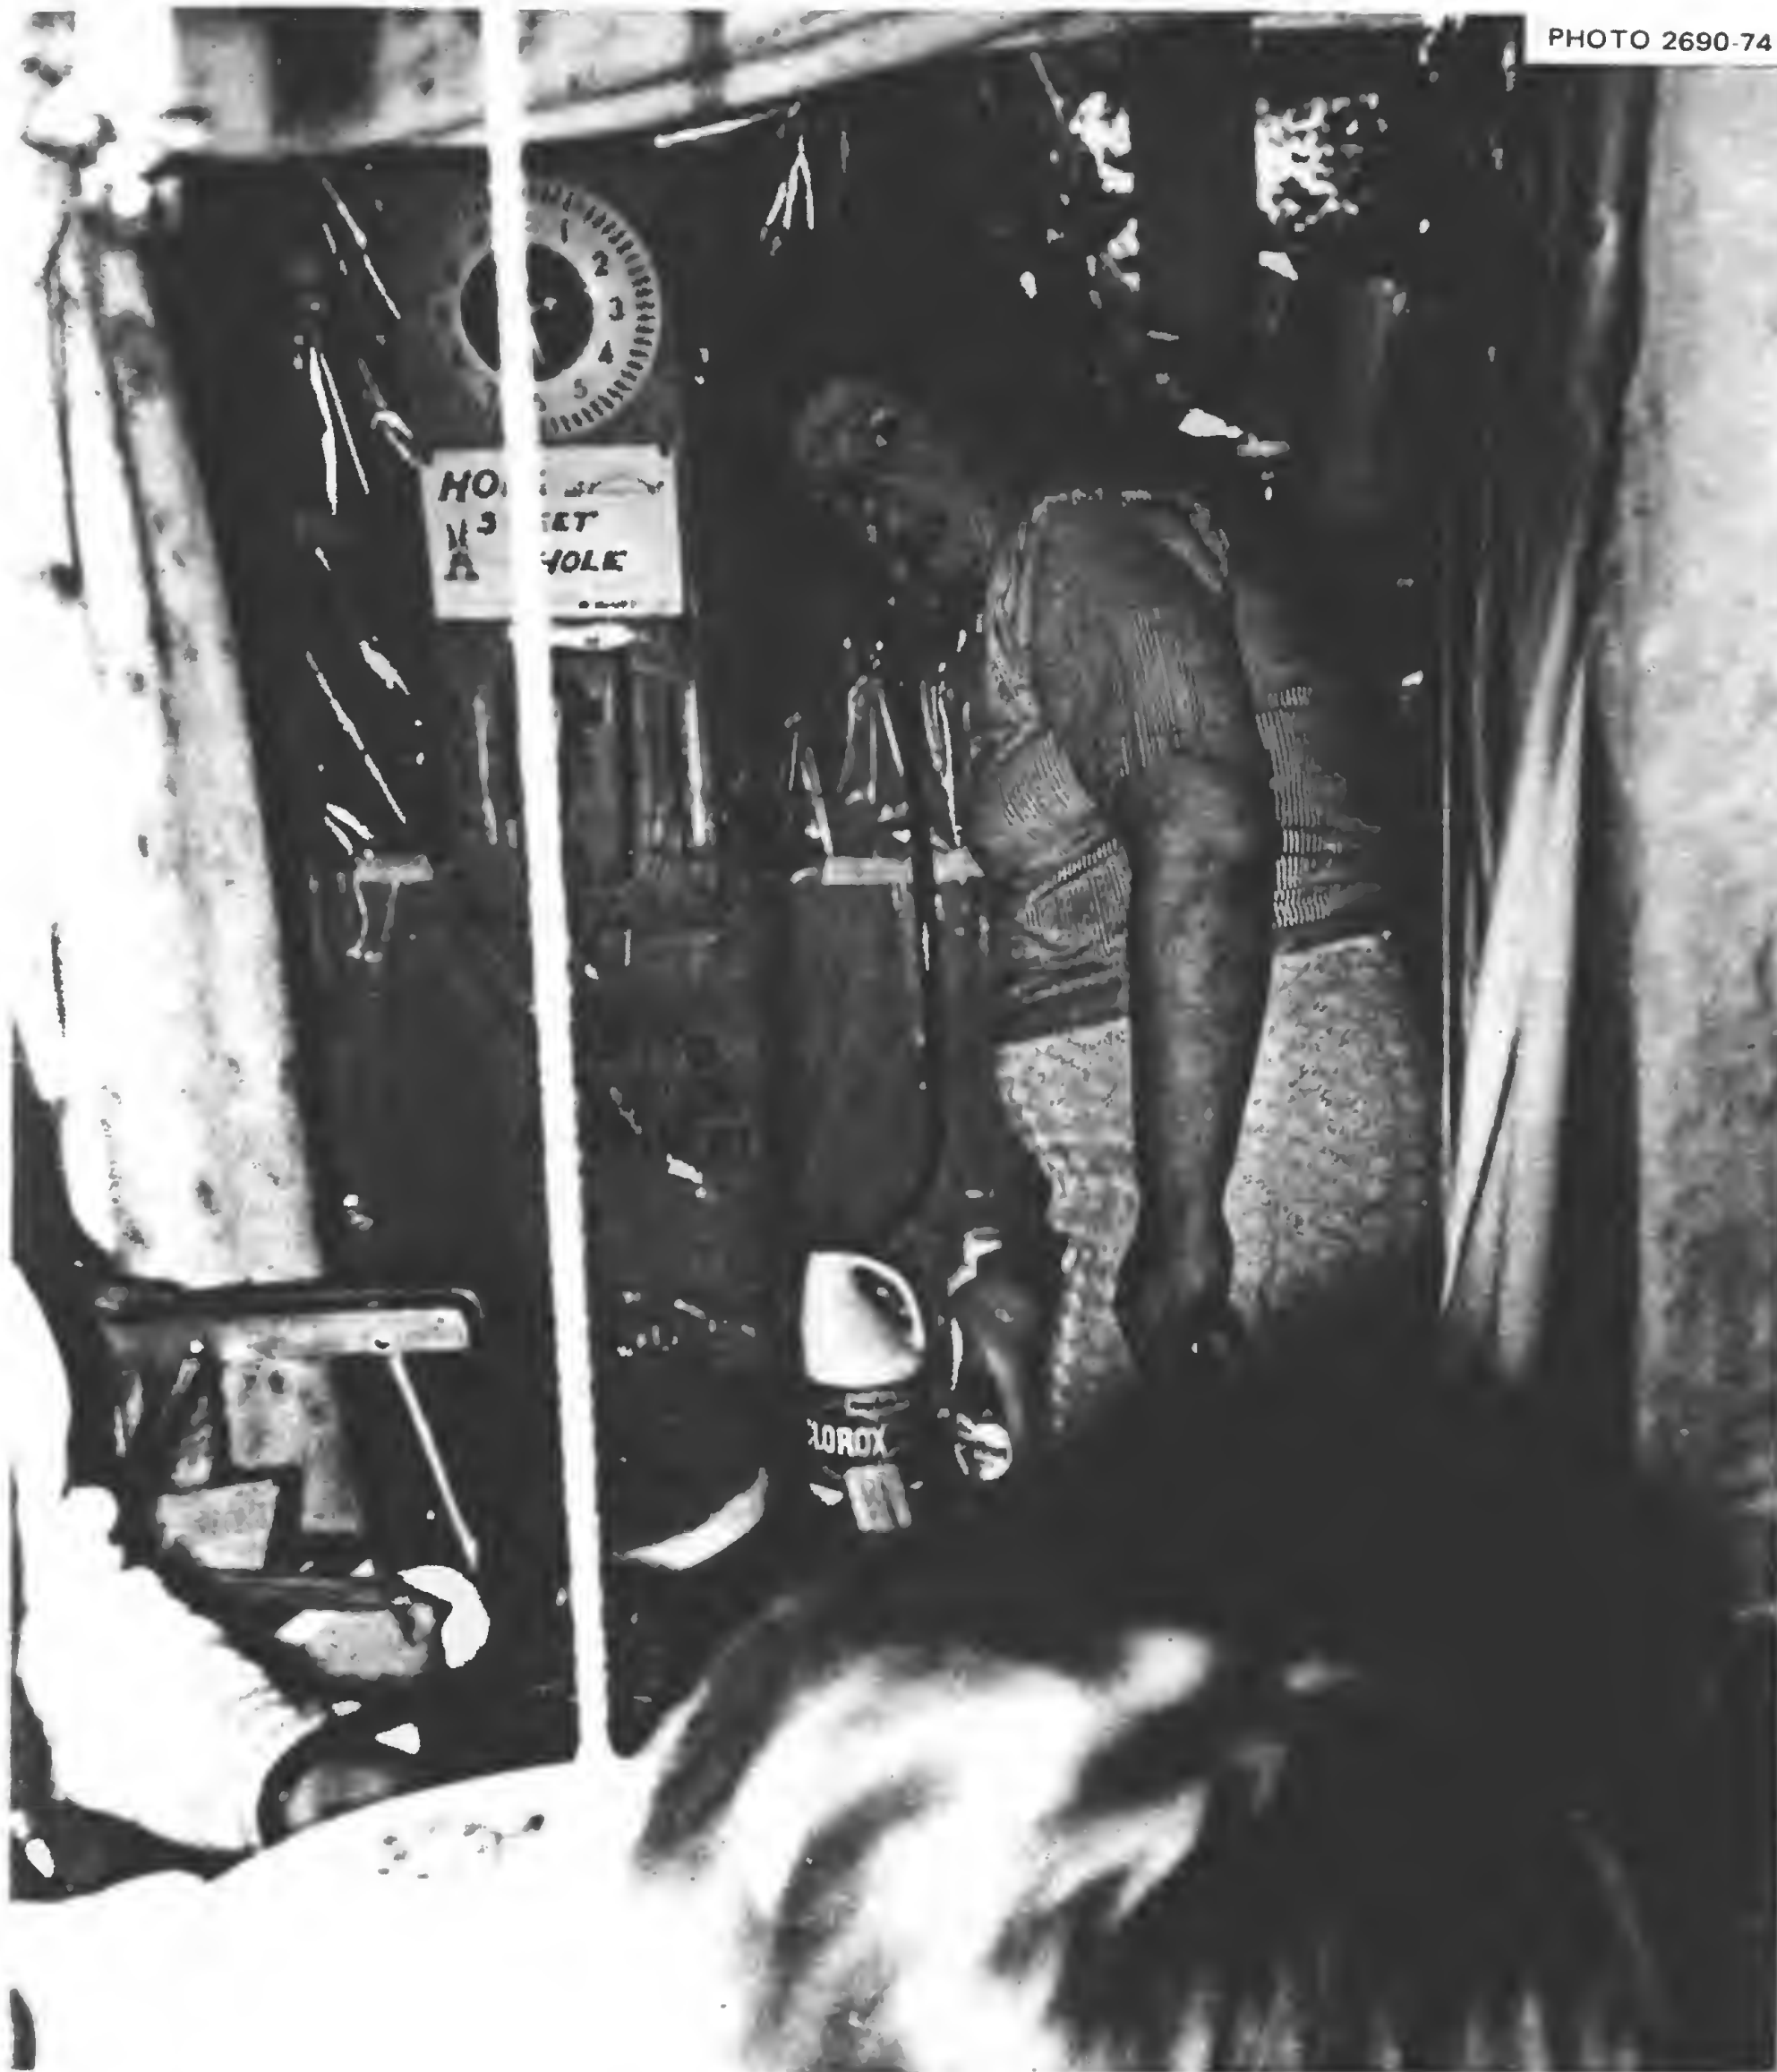
Fig. 4.23. The mother standing in the 18-in.-deep stand-up hole next to the toilet. Note the air-duct-emergency exit, shown above the mother's shoulders, with a piece of toilet paper hanging from its roof to indicate air movement.
